ESTONIAN CULTURAL HERITAGE

CONSERVATION OF PUURMANI MANOR

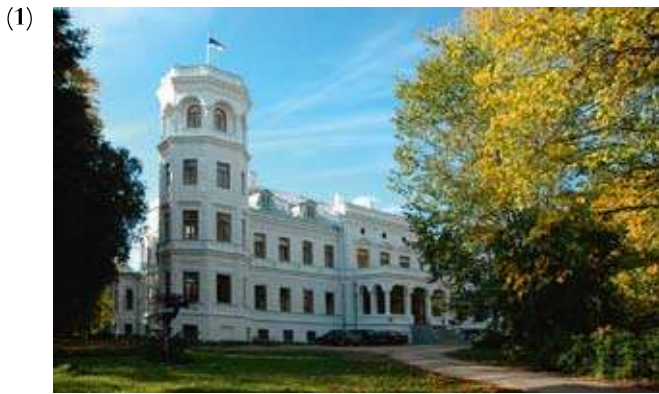
- (1) Puurmani manor. Photo by Anatoli Makarevit
 (2) The dining room with its well preserved wallpaper was the biggest surprise. Photo by Raivo Tasso
 (3) Two layers of wallpaper were found on the walls of the former dining room. The older layer dating back to the 1880s is decorated with a composition of various hunting trophies. Photo by Kadri Kallaste
 (4) *Chinoiserie* wallpaper of European origin was revealed under the wall panelling of the countess's dressing-room. The tile stove after minor repairs. Photo by Raivo Tasso
 (5) The wooden panelling on the lower part of the countess's bedroom wall revealed a wallpaper with pastoral motives. In order to display the wallpaper, part of the panelling was removed and replaced by a layer of glass. Photo by Kadri Kallaste

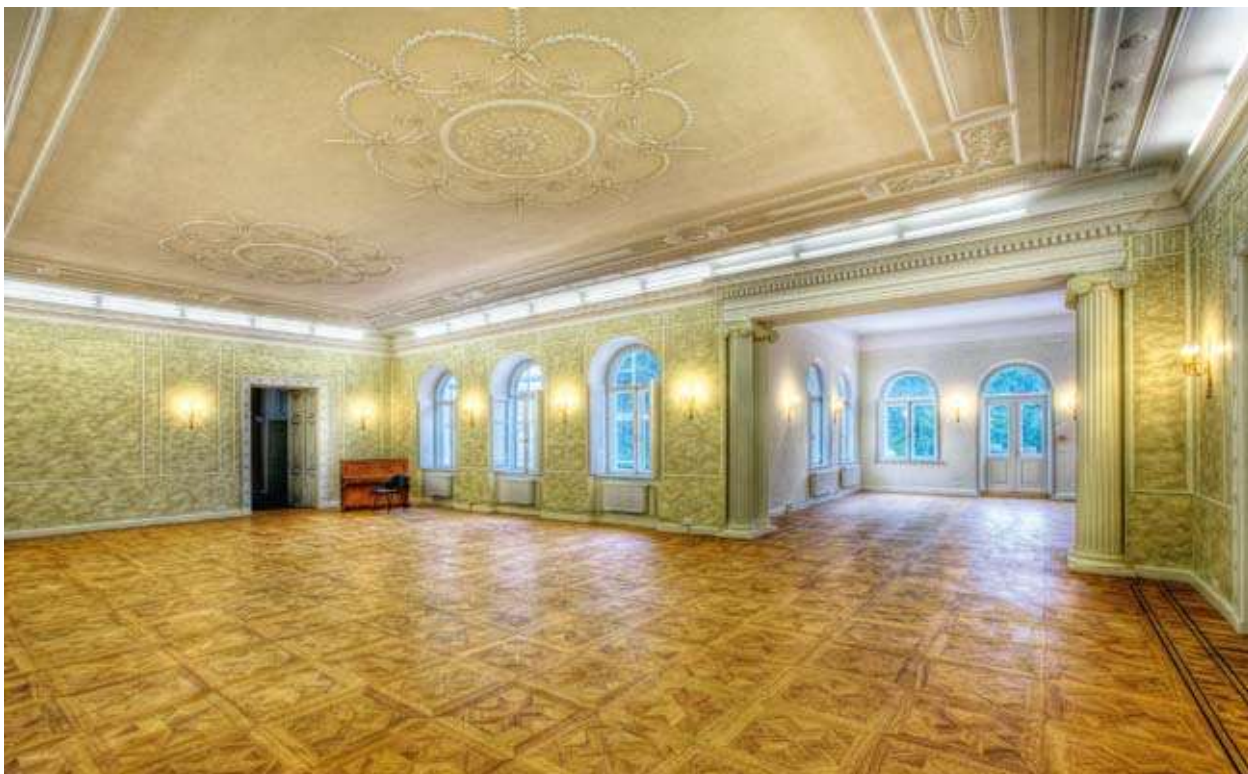
(6) The main hall after conservation. Studies revealed faux marbling on the lower part of the walls that was restored by OÜ Vana Tallinn. The floors of the main hall and the adjacent greenhouse were covered with newly assembled parquet panels, the exact copies of the original ones. Photos by Raivo Tasso

In addition to the rare wallpapers, a faux marbling imitating sandstone was found on the walls of the ground floor hall. An uncovered area was made to display the old faux marbling while the rest of the wall was reconstructed taking the original as a model. In several rooms there were stencil paintings that were partly uncovered and conserved.

In the beginning, it was planned to conserve the old parquet floor of the main hall but it turned out that after grinding it would have been only a millimetre thick and, therefore, it was decided to replace it with new flooring except in one corner where the old parquet was displayed. The newly assembled parquet panels were made to the exact measures and design of the old ones. Parquet was

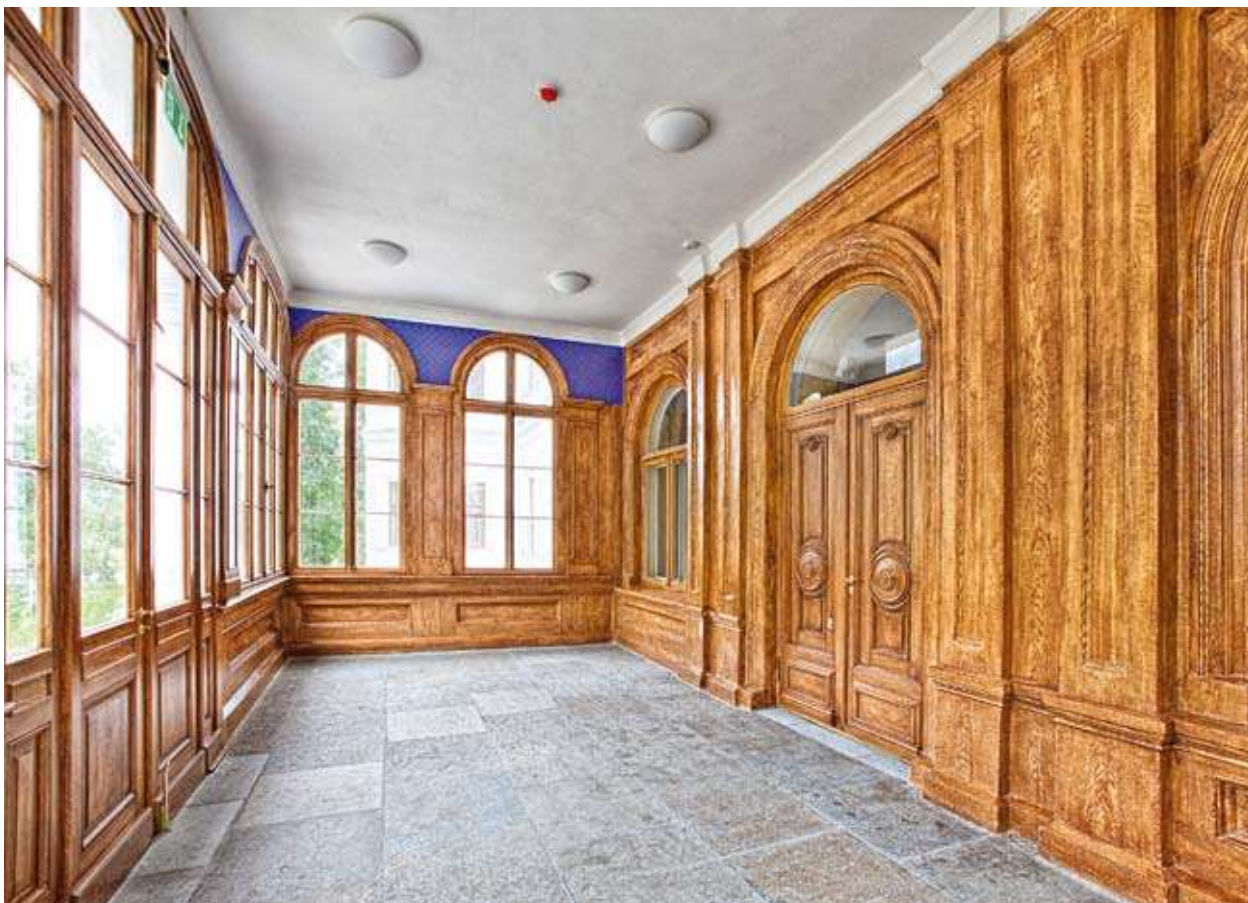
(7) The walls of the foyer revealed grained surfaces and bright blue colour

In the earliest finishing layers of doors and wall panelling traces of gilding were found. Uncovered areas were left on doors to display all the paint layers. Rich wooden adornments on doors and door jambs were stripped to the first paint layer and restored. At some point, many of the doors and windows had been grained. On the double-doors of the dining room the painting imitating wood grain was surprisingly well preserved and after slight retouching it was displayed.
