**Preservation of Wallpapers as Parts of Interiors.
Addressing Issues of Wallpaper Conservation on the Basis of
Projects Carried out in Austria, Estonia and Romania**

Doctoral thesis
Doktoritöö

Estonian Academy of Arts
Faculty of Art and Culture, Department of
Conservation and Cultural Heritage
2013

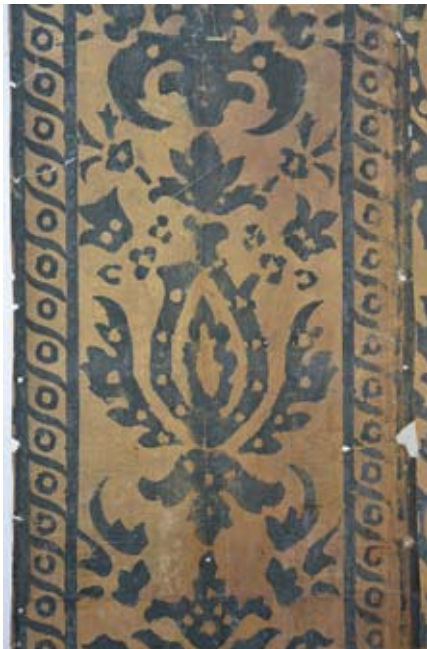
Figure 65. A stencilled wallpaper produced in the 1860s found in the Freyschlösschen in Salzburg, Austria.

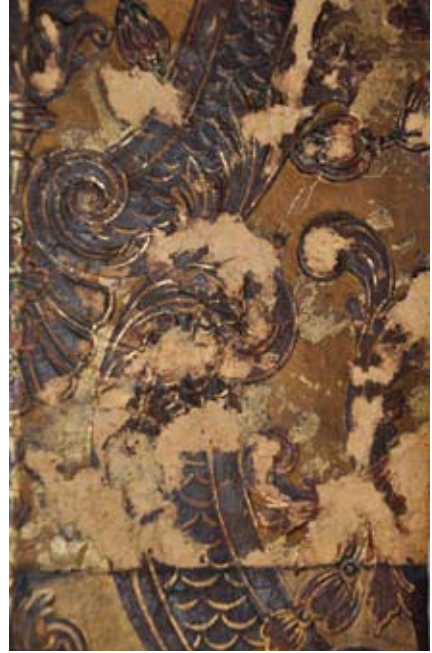
Figure 80. Wallpaper heavily damaged by careless handling during dismounting.

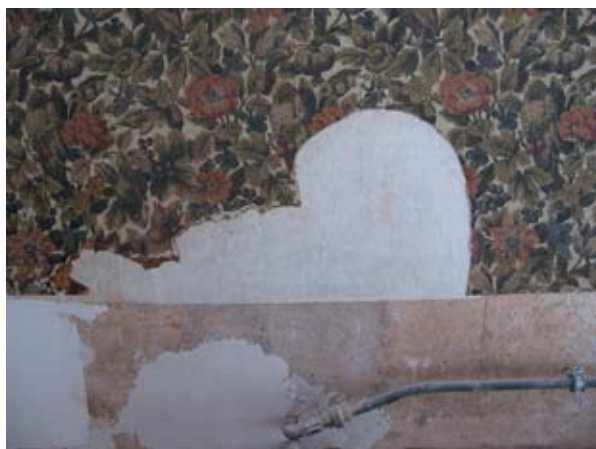
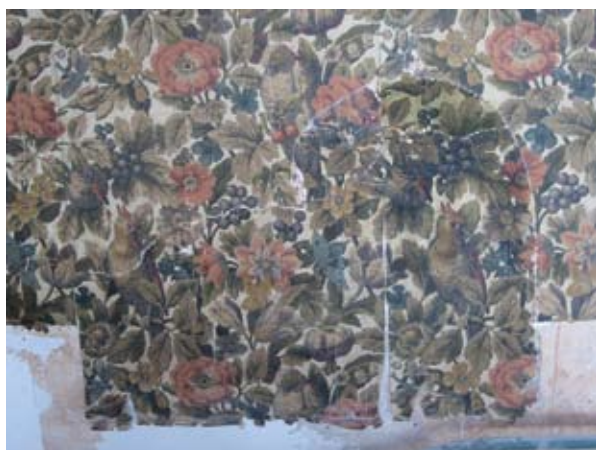
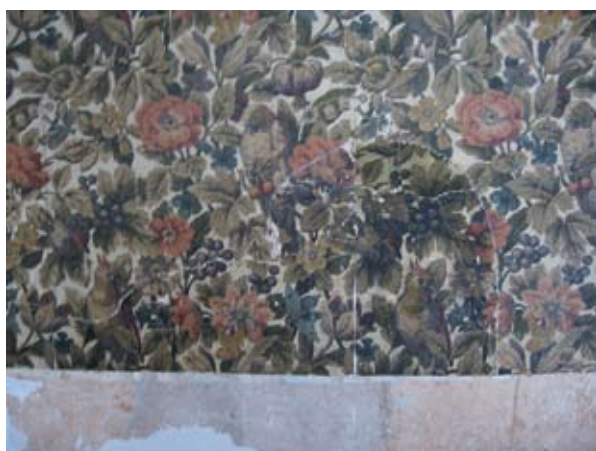
Figure 95. Large missing areas in the wallpaper were filled with fragments found behind the overdoors of the dining-room of the Puurmani manor.

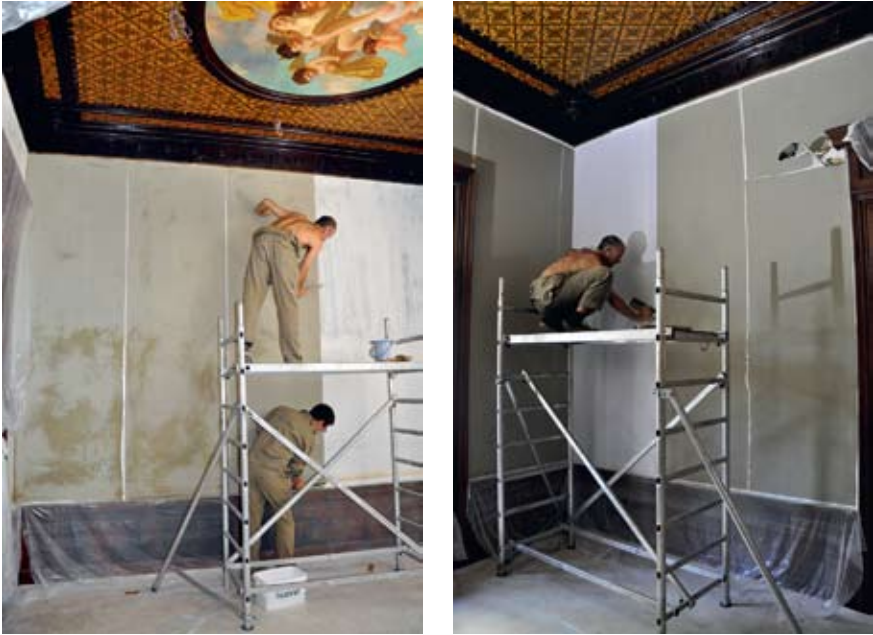
Figure 99. An easily removable mounting system was built up in the Theodor Aman Museum in Bucharest. It consisted of a layer of thin cotton canvas and two layers of non-acid lining-paper.

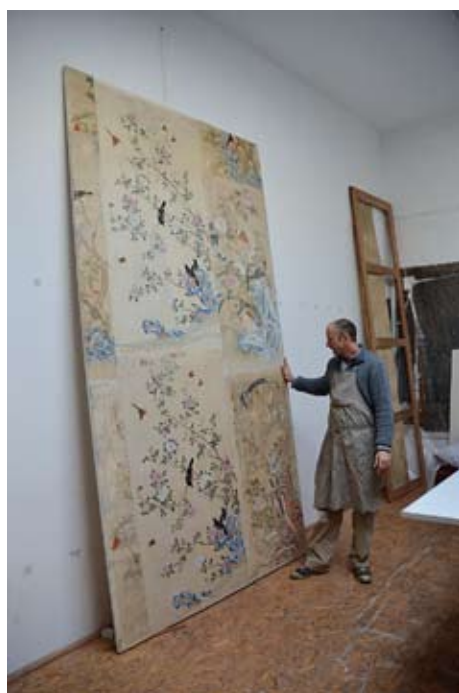
Figure 100. Large prepared *shoji* frames before and after mounting the panels of the Chinese wallpapers from the Esterhazy Palace.

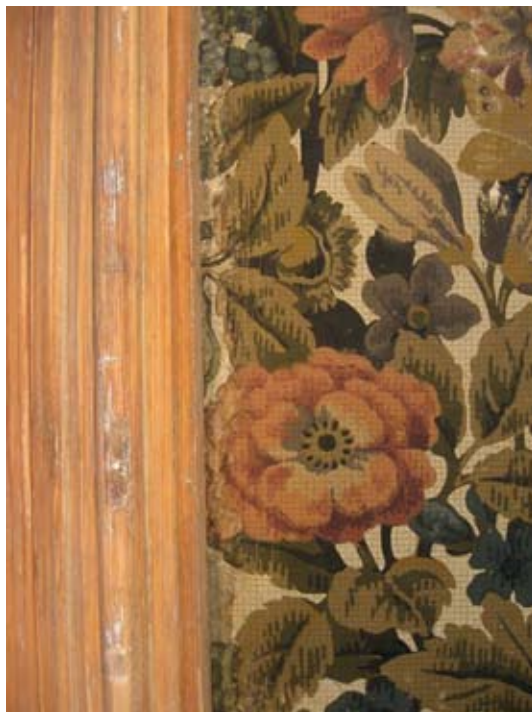
Figure 101. Missing areas in the wallpaper of the Puurmani manor's dining-room were integrated into the rest with the help of modelling lines in matching tones.

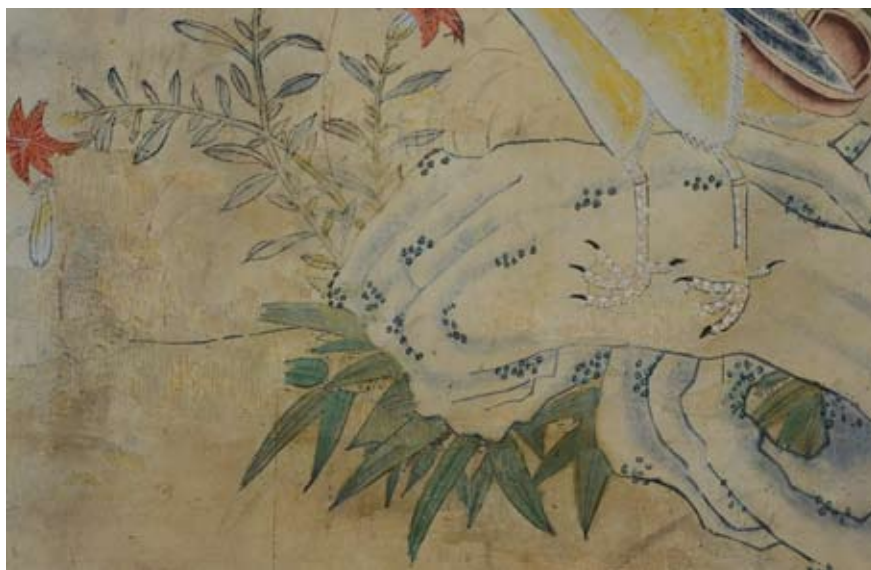
Figure 102. Large losses have been treated with a method interpreting *Tratteggio*.

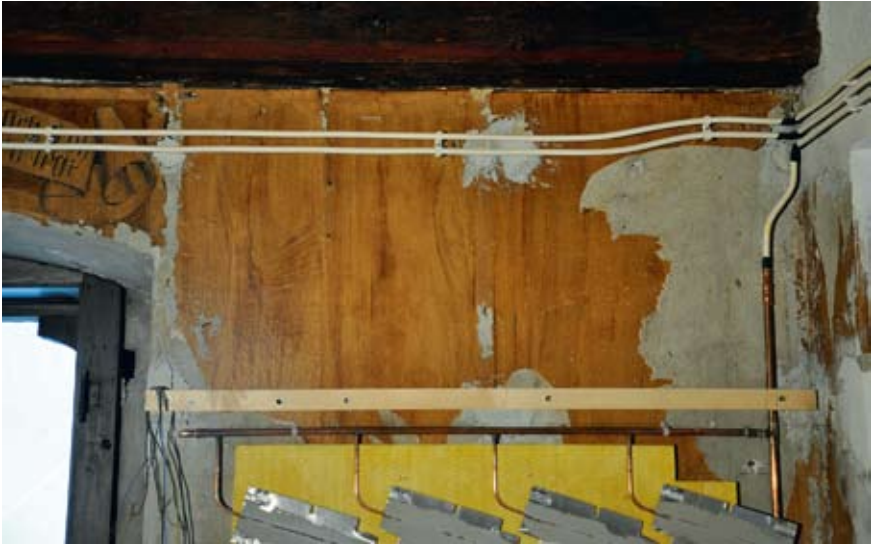
Figure 103. If damaged wallpapers are not planned to be exhibited, they should not be retouched.

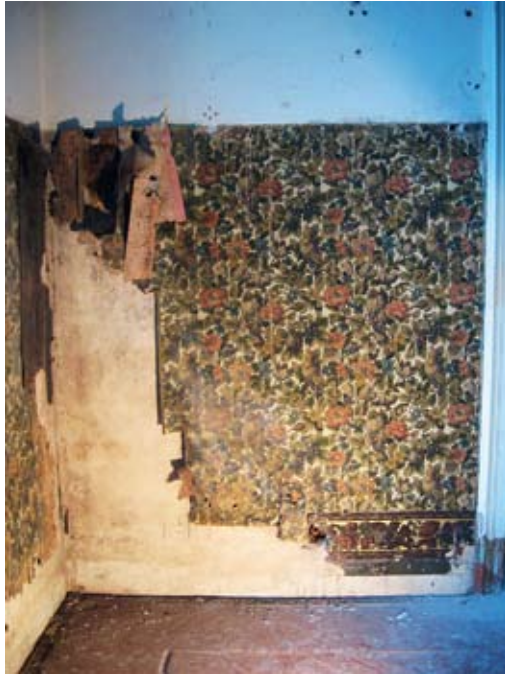
Figure 114. Corner of the dining-room badly damaged by humidity and mould.

Due to a defective rainwater pipe on the facade, the corner facing the main hall had been extensively damaged by humidity, which led to mould and discolouration of the object. **(Fig. 114)** Since five strips of heavily moulded wallpaper with borders and monochrome papers were hanging loose from the wall, it was decided to dismount and conserve them in a conservation workshop in Tartu. In addition, mechanically damaged borders from sections between windows were removed to allow for better treatment. During the conservation treatment, it became apparent that the older layer of wallpaper had been partially stripped from the wall before new wallpaper was applied. Without removing the damaged strips, it would not have become clear that only fragments of the older wallpaper had survived. Although the author had given some thought to opening and exhibiting the older layer of wallpaper within a segment of a wall, this proved to be too risky without further comprehensive research. Due to limited finances and a tight deadline, this was considered to be unreasonable. Thus it was decided to open a smaller area showing only two repeats of the pattern. Fragments

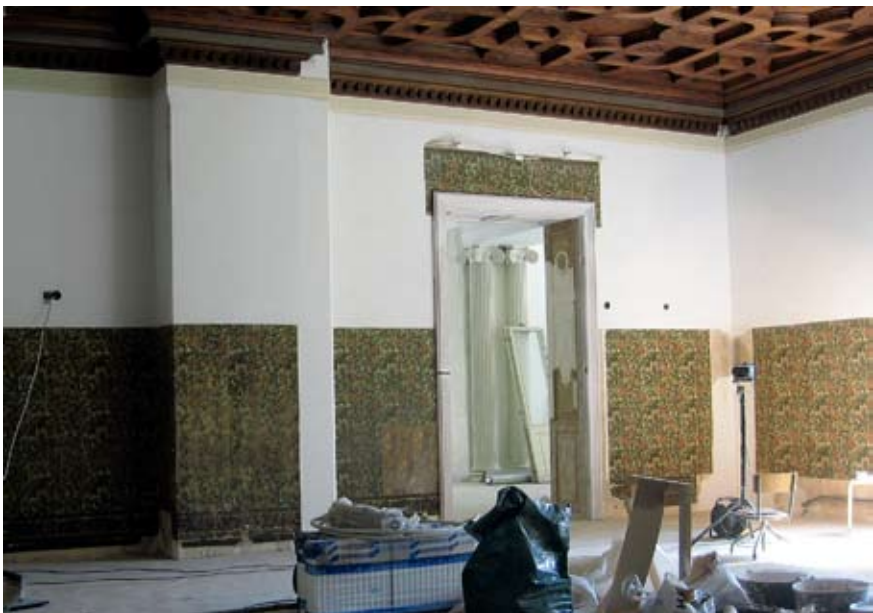
Figure 115. After removal of the wooden over-doors, large fragments of wallpaper and border were discovered.

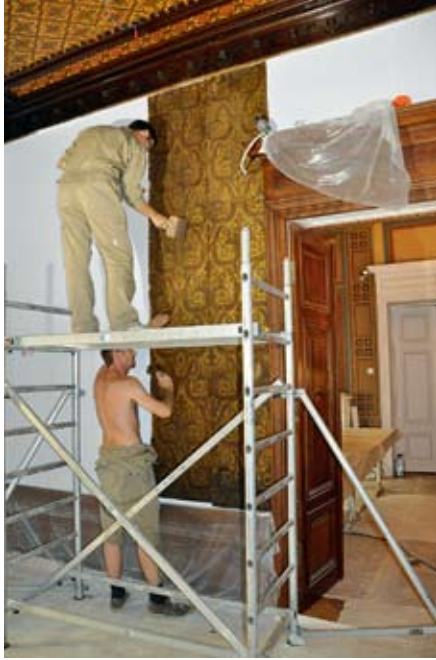
Figure 135. Each strip and segment was remounted to its original location.

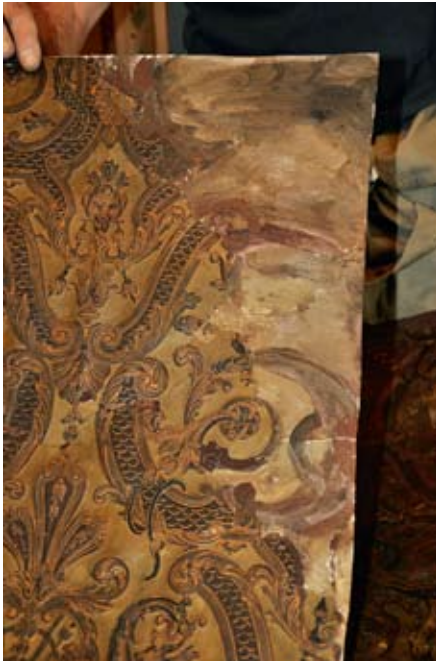
Figure 136. Poorly retouched and over-painted areas and needed to be improved.

Since removing the paint would have caused further damage, it was decided to hide the signs of the previous treatment with a layer of glazing. Large losses of over-paint were filled with streaking in neutral tones, and smaller losses were in-painted using matching neutral tones. After testing various paints, such as watercolours, gouache, gouache with acrylic binder, acrylic paint, crayons and pastels, it was decided that the texture and

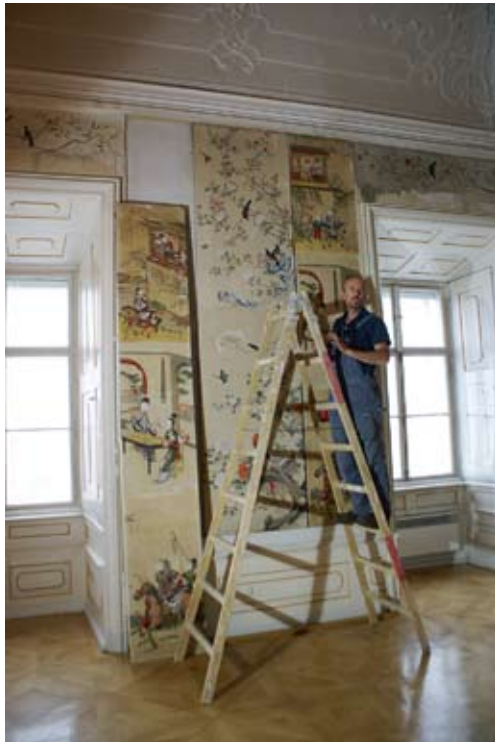
Figure 143. All the panels carrying the wallpapers were dismantled from the wall.

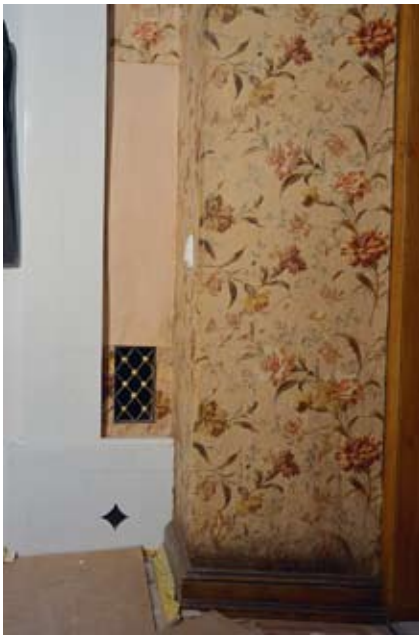
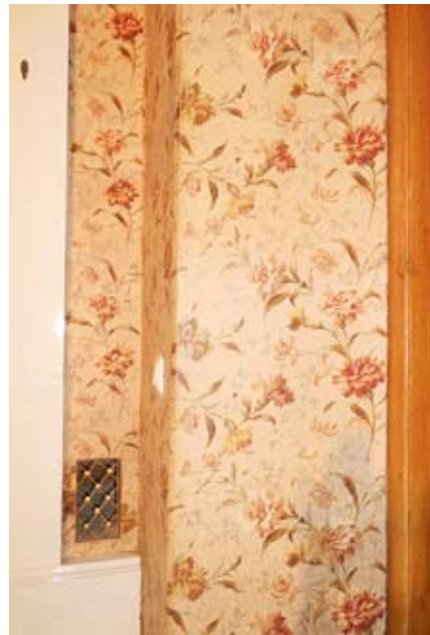
Figure 161. Missing area before and after reconstruction *in situ*.

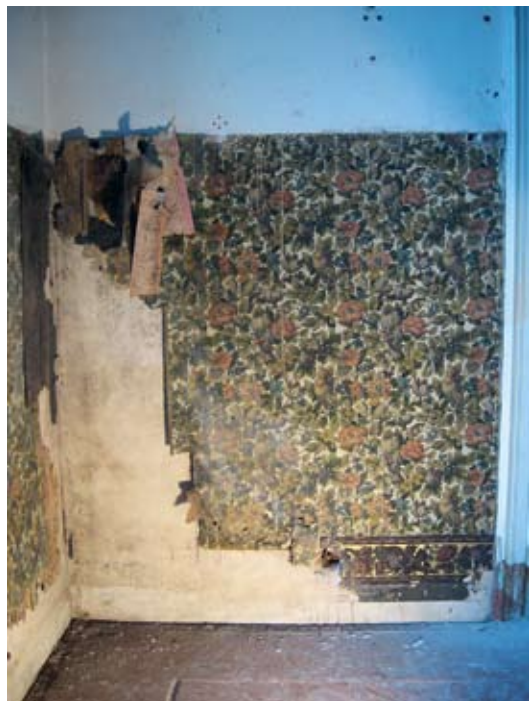
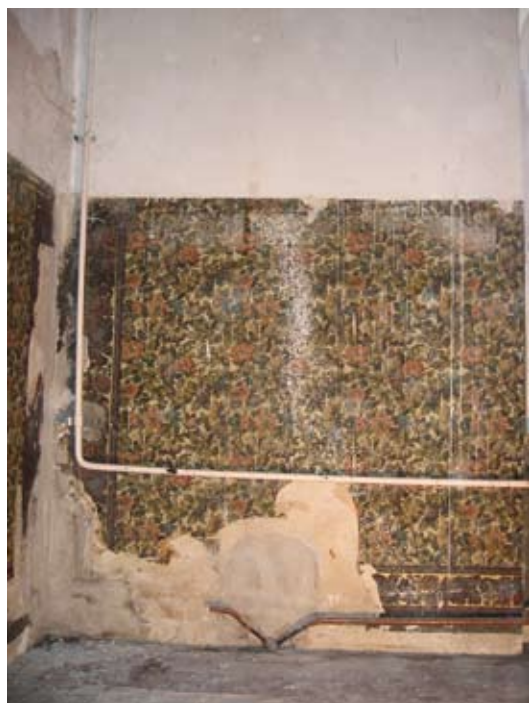
Figure 170. Condition of the wallpaper after the removal of the wooden paneling.

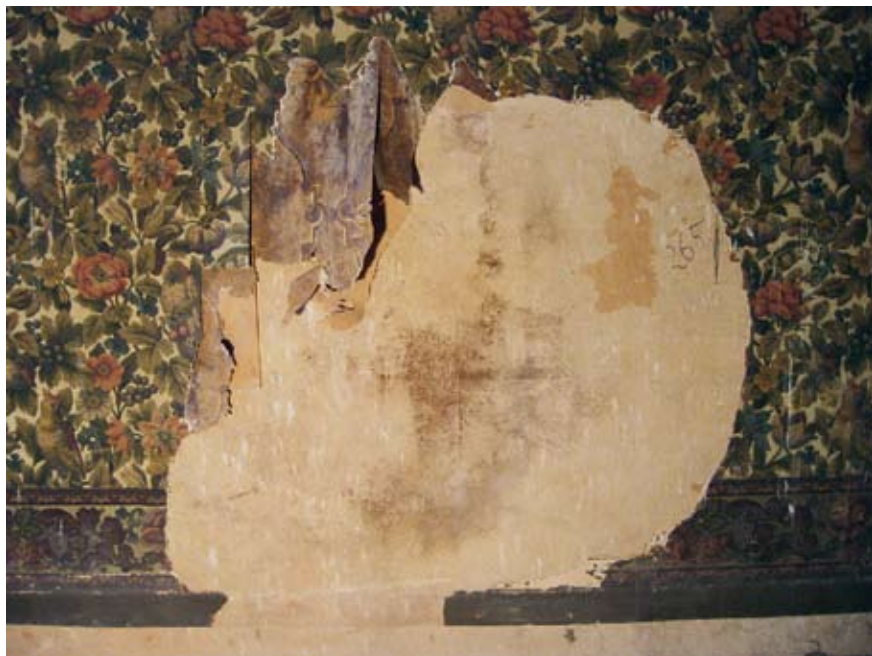
Figure 172. Large area of missing wallpaper.

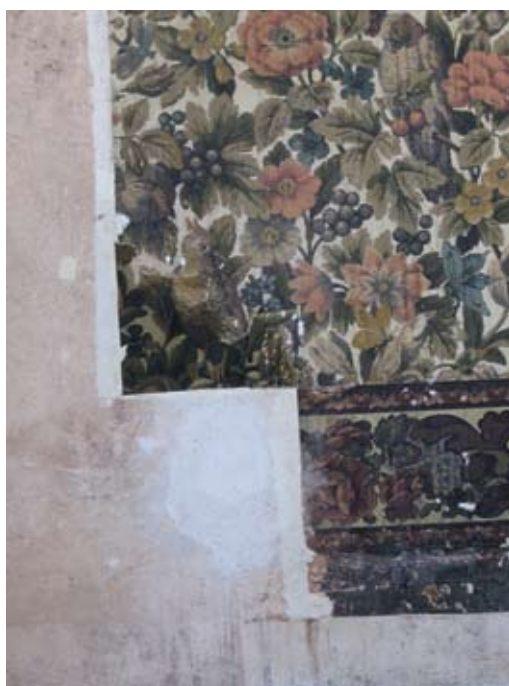
Figure 180. Small missing areas were filled with the wallpaper fragments found behind the wooden overdoors.

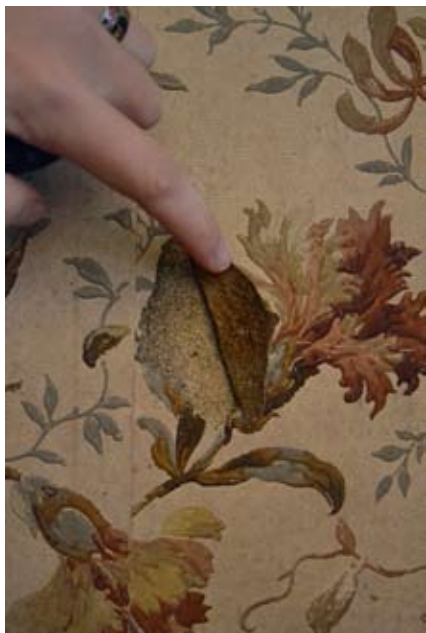
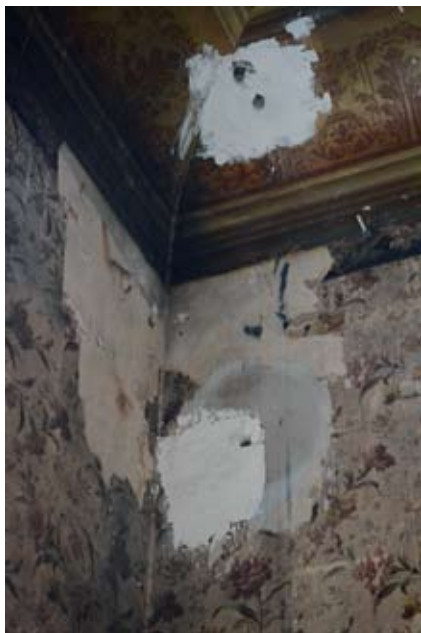
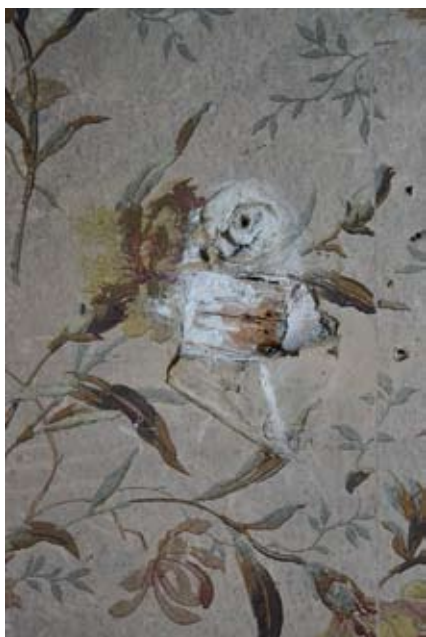
Figure 186. Different types of damages.

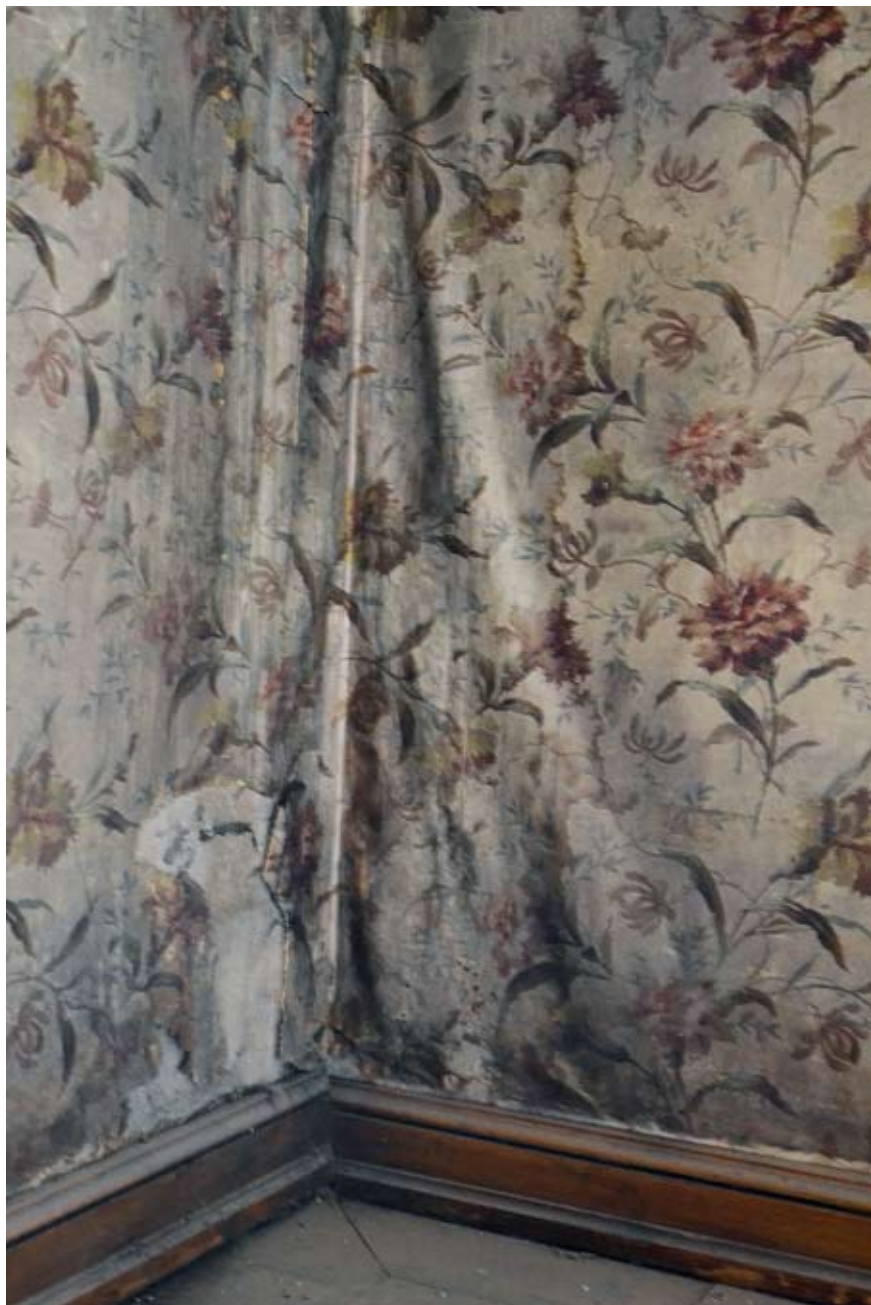
Figure 187. Corner damaged by humidity and dark tidelines.

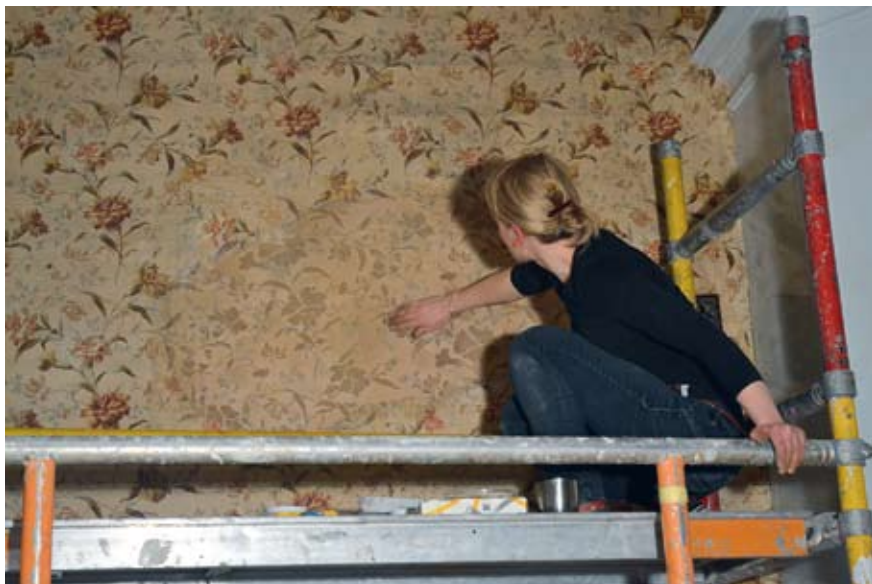
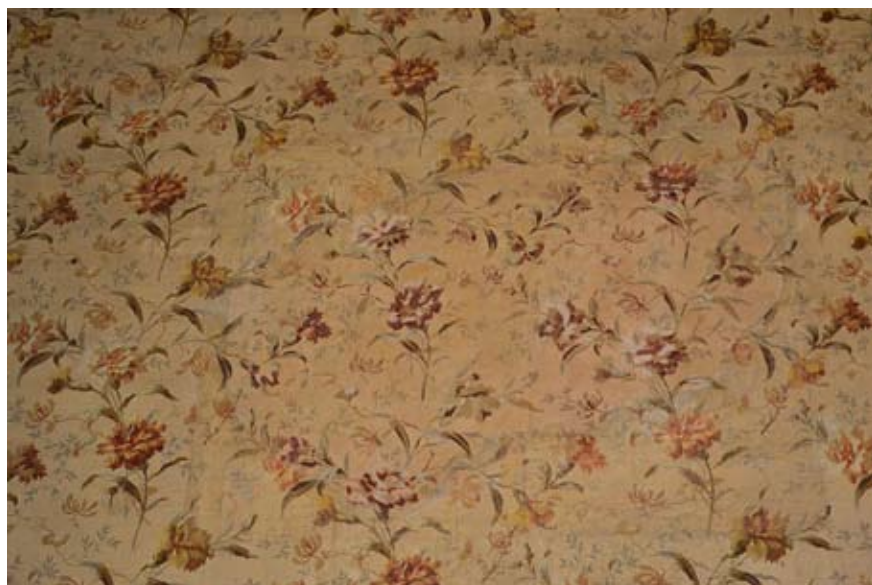
Figure 192. The missing area was reconstructed in situ by using stencils and painting.
