ESTONIAN CULTURAL HERITAGE

THE NEED AND METHODS OF STUDYING HISTORICAL WALLPAPERS IN ESTONIA

Kadri Kallaste and Viljar Vissel

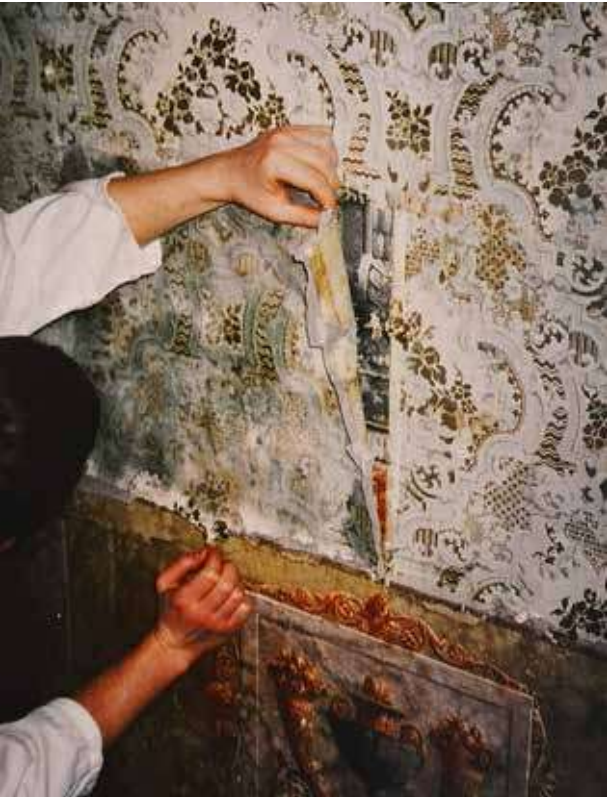
(1) *In situ* research. The uppermost layer can be separated from the lower ones by a prophylactic layer made of Japanese paper. Photo by Andreja Dragojevic (2) Older wallpaper layers can also be displayed as sample areas. Photos by Kadri Kallaste (3) Wallpapers surviving in their entirety can often be found behind panelling. The neo-Rococo panelling in the dressing room of the countess of the Puurmani manor revealed a beautiful Chinoiserie wallpaper (4) A wholly surviving 1930s wall scheme discovered during interior finishing work at Roopa 11 in Tallinn

1. *In situ* research. Researching wallpapers in their original location can yield material in layers, as well as fragments. Besides the design, printing method and the materials of the wallpaper, this makes it possible to study the context and fitting. If the wallpaper has already been removed from the wall (destroyed), only fragments can be studied. This situation is unfortunately prevalent in Estonia. In order to find fragments, the surfaces underneath floors, doors and window casings should be inspected. It is also advisable to check behind cupboards, wall panelling, window shutters and switches.

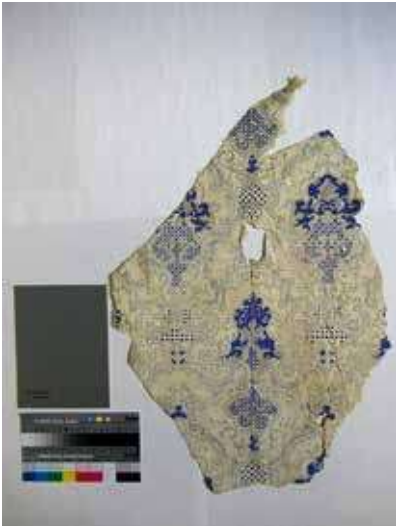
(5) The first layer of wallpaper in the room adjacent to the big hall in the Juuru vicarage, dating back to the renovation in 1842. Photos by Viljar Vissel (6) Wallpaper of the 1860s with stylised ivy vines in the office of the Juuru vicarage (7) The third layer of wallpaper, from 1875, in the office of the Juuru vicarage (8) Unique wallpaper imitating drapery in the main building of the Loodi manor. Turn of the 18th–19th centuries. Photo by Karin Ojaste (9) Late 18th century wallpaper resembling Tarot cards and inspired by motifs of nature in the former staircase in the main building of the Loodi manor. Photos by Viljar Vissel (10) The second layer of wallpaper with lavish ornamentation in the former staircase in the main building of the Loodi manor dates from the mid-19th century (11) Striped wallpaper from the early 19th century in the main building of the Loodi manor

Among the latest examples of wallpaper research are the historical wallpapers found in the Juuru vicarage and in a wing of the Loodi manor. In 2012, 65 different kinds of wallpaper were discovered in the six rooms of the Juuru vicarage, made between 1840 and 1980. The building itself dates from the second half of the 18th century. The fine architecture of the building indicated quite clearly that the seemingly modest interiors might conceal much more. Great help in dating the wallpapers was provided by the careful recording in the Juuru church chronicles of repairs and reconstructions. A significant dating method involved comparing the style of ornaments with analogues. Analysing the layers revealed the extent of repairs. The Loodi manor wallpapers date from the post-construction period and were discovered in summer 2013, when a plan for preparatory research was being compiled. This is a remarkable find and offers an excellent overview of the original design of the whole floor. Besides drapery and contrasting striped wallpaper, mention should be made of the first of the two wallpapers in the former staircase. The pattern, with even distribution resembling Tarot cards, is adorned with naïve geometrical figures inspired by nature.

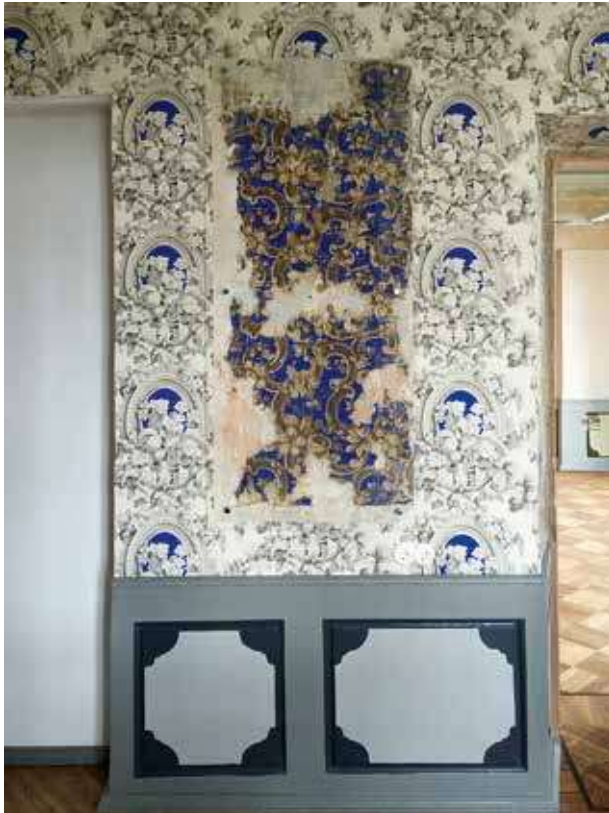
(12) Wallpaper fragment displayed in the main building of the Suuremõisa manor, with a bit of painted panelling showing underneath
 (13) Velvet wallpaper with printed gold ornamentation on the ground floor in the main building of the Suuremõisa manor (14) Restored wallpaper in the first floor drawing room in the main building of the Suuremõisa manor

The interior of one of the biggest and grandest Baroque manor houses in Estonia was also decorated with a large number of different wallpapers. The building, used today by the Hiiumaa vocational school, was restored in 2014–2016. Unfortunately, time was limited and money and skilled workmen were scarce. The modest budget of restoration work sometimes justifies the well-known sentence, "Poverty conserves". With its large number of interior finishing layers, the Suuremõisa manor can actually be grateful to the tight budget: so much material was left over for future research. Before the latest restoration, extensive research into the interior finishing was carried out in the building. Besides specialists, students were involved, and did thorough preparatory work, among other things selecting wallpaper fragments with eloquent patterns to be displayed. Among the surviving wallpapers were four discoveries covering an especially extensive area. It was decided to restore two, as their condition was pretty dismal. Towards the end of the work, the National Heritage Board turned to paper conservators of the Estonian Open Air Museum's conservation and digitalisation centre Kanut, asking them to determine the quality of work. Not much good can be said about the restoration of these two wallpapers. The biggest achievement was perhaps the post-restoration general outlook of the blue wallpaper, whose brightness impresses all visitors. Unfortunately, massive overpaintings make it impossible to distinguish the wallpaper's original area. The idea of restoring the ground floor velvet wallpaper was brave, but the results are catastrophic. Displaying fragments surviving across the room on just one wall is impossible even in theory. Instead, the better preserved panels should have been chosen for display. The current outcome does not make it possible to see the charm of the wallpaper's printing techniques, which seem to have been originally luxurious and hedonistic.
